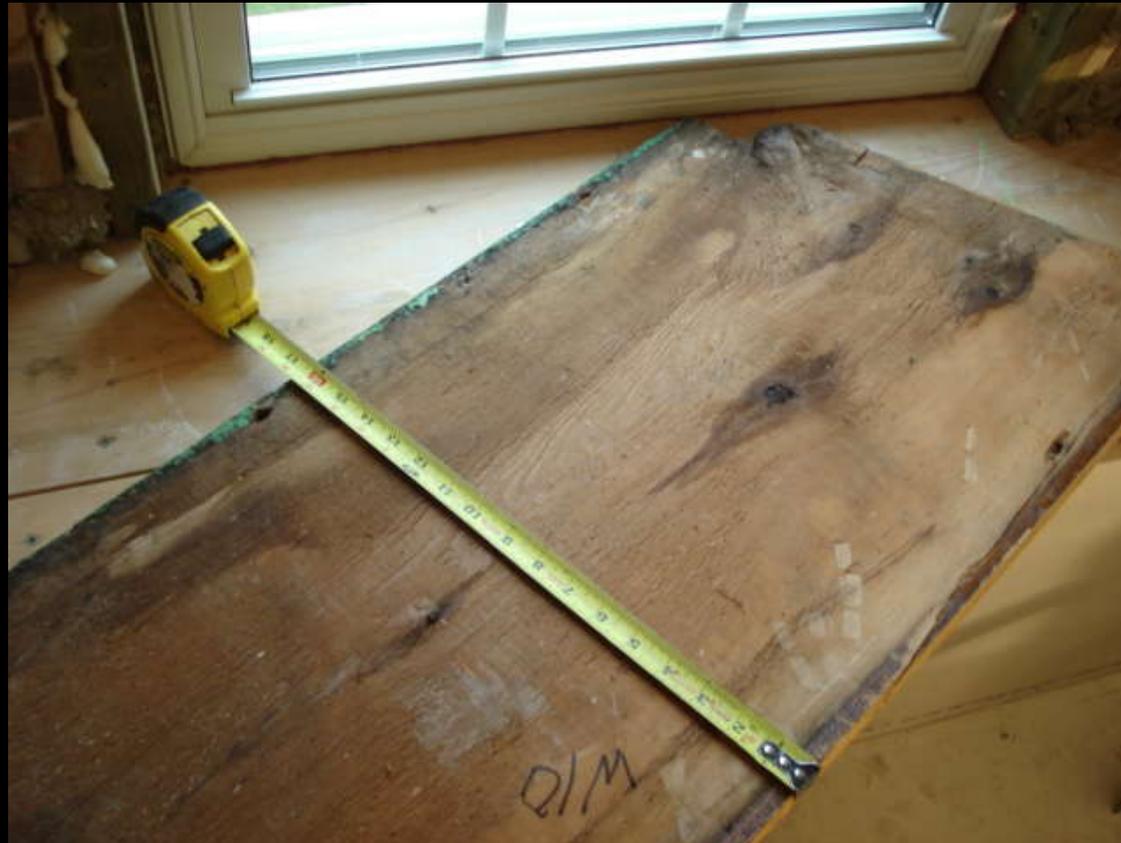
This sill is 16 ½” wide, one sawn board, 1” thick – 1860 reclaimed

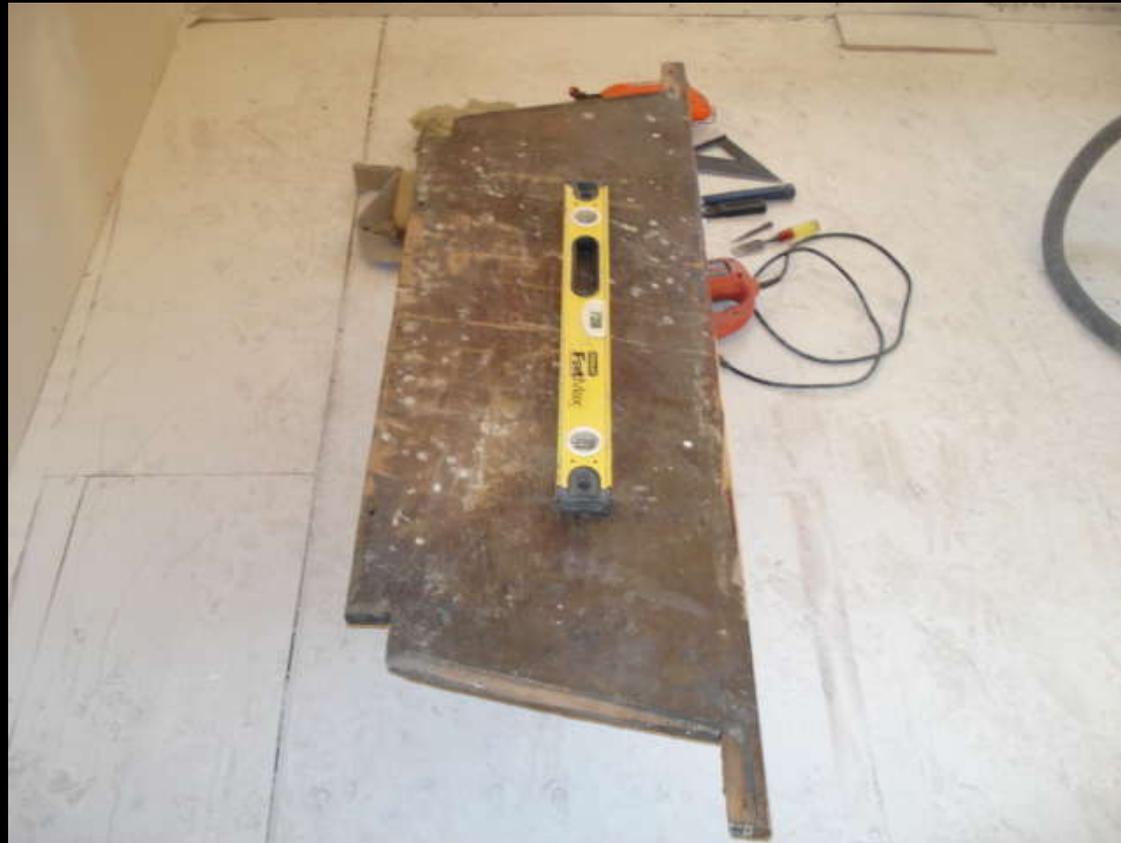
This 1860 sill, cut and trimmed to fit in the window well

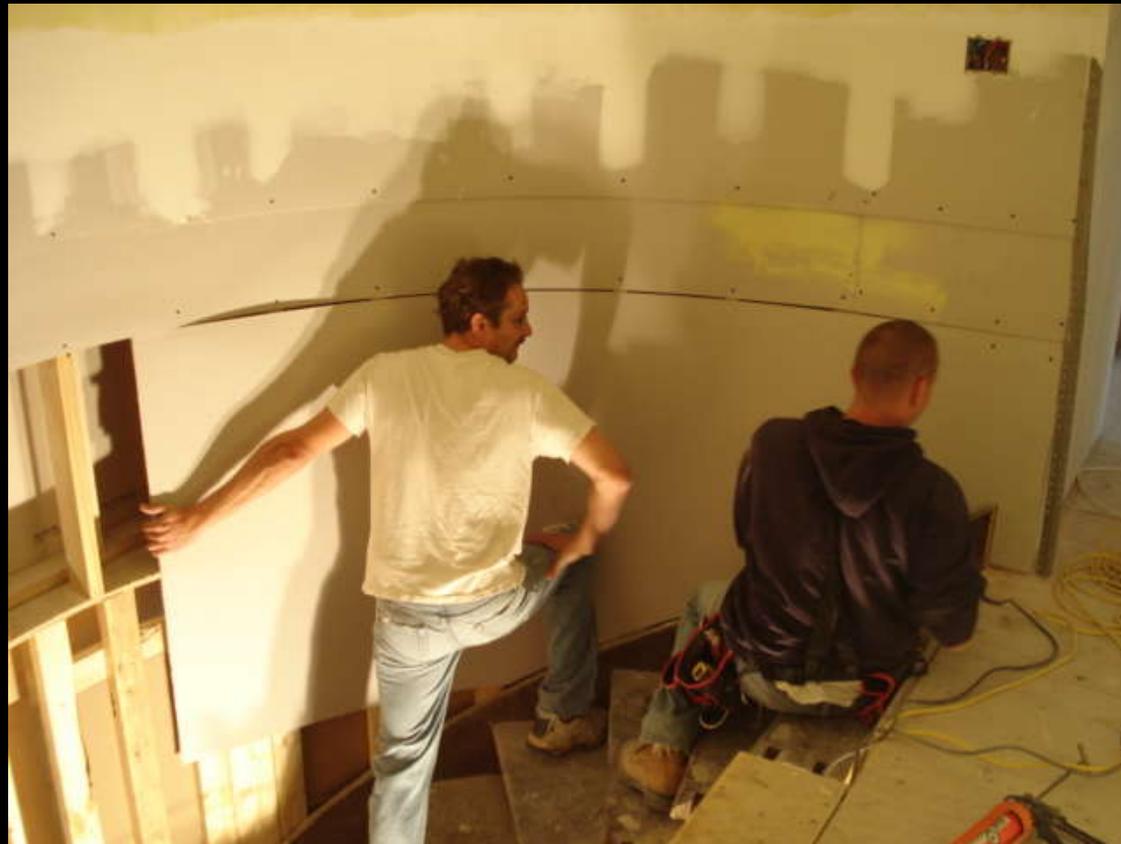
Steve & Brad installing the lower portion of 1/4" drywall curve

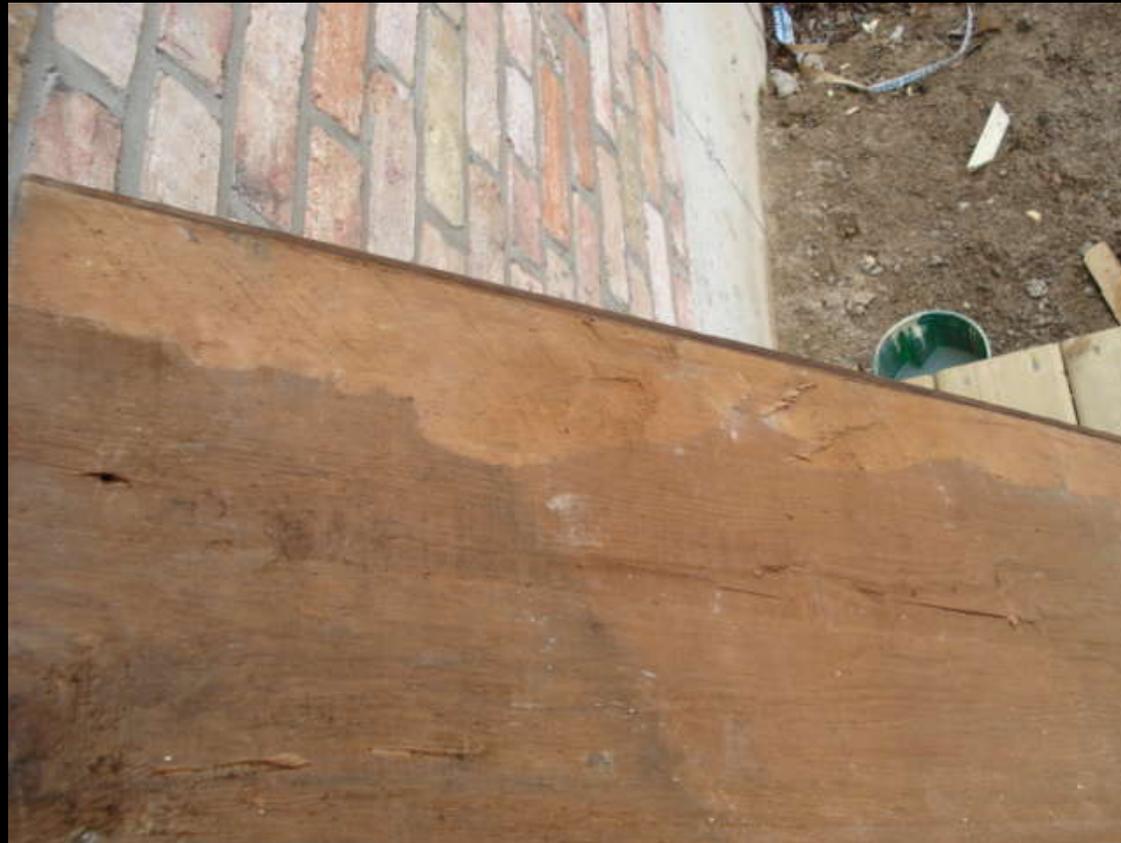
In 1860 the carpenter trimmed the back of this side panel with an adze

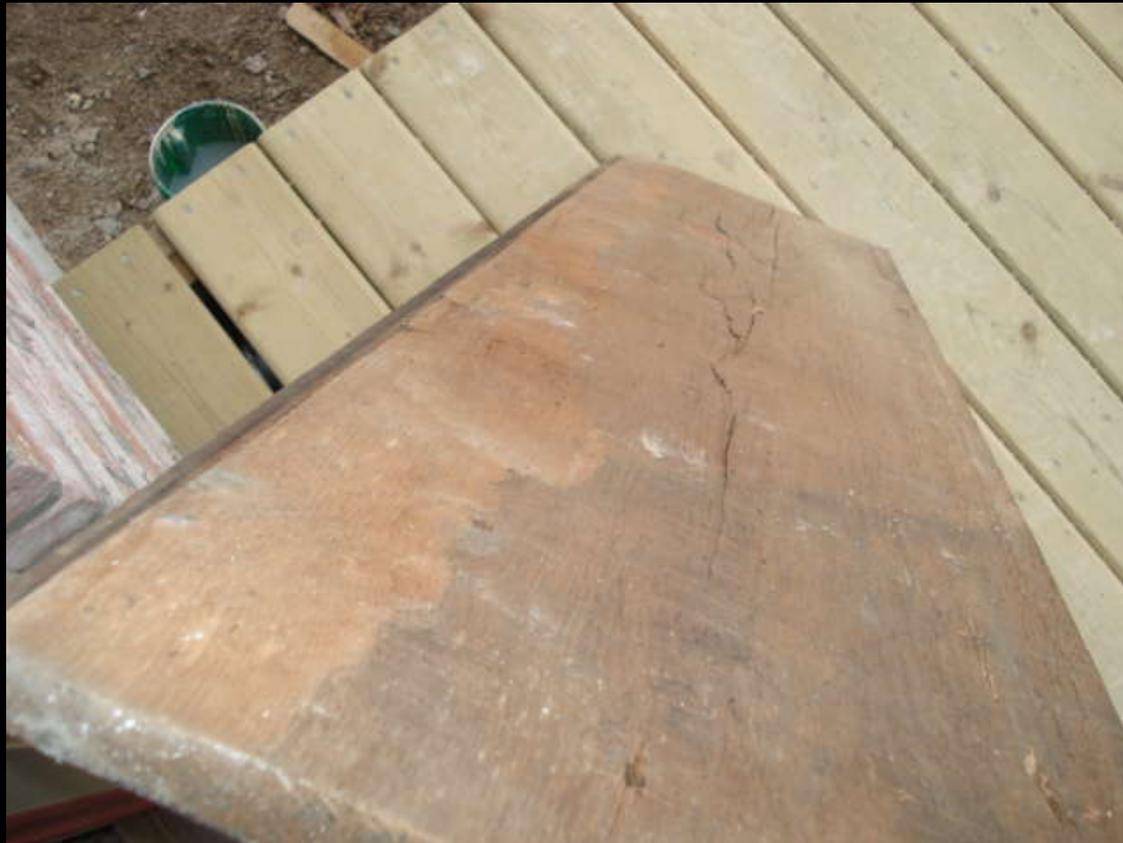
Adze work to fit over stone walls

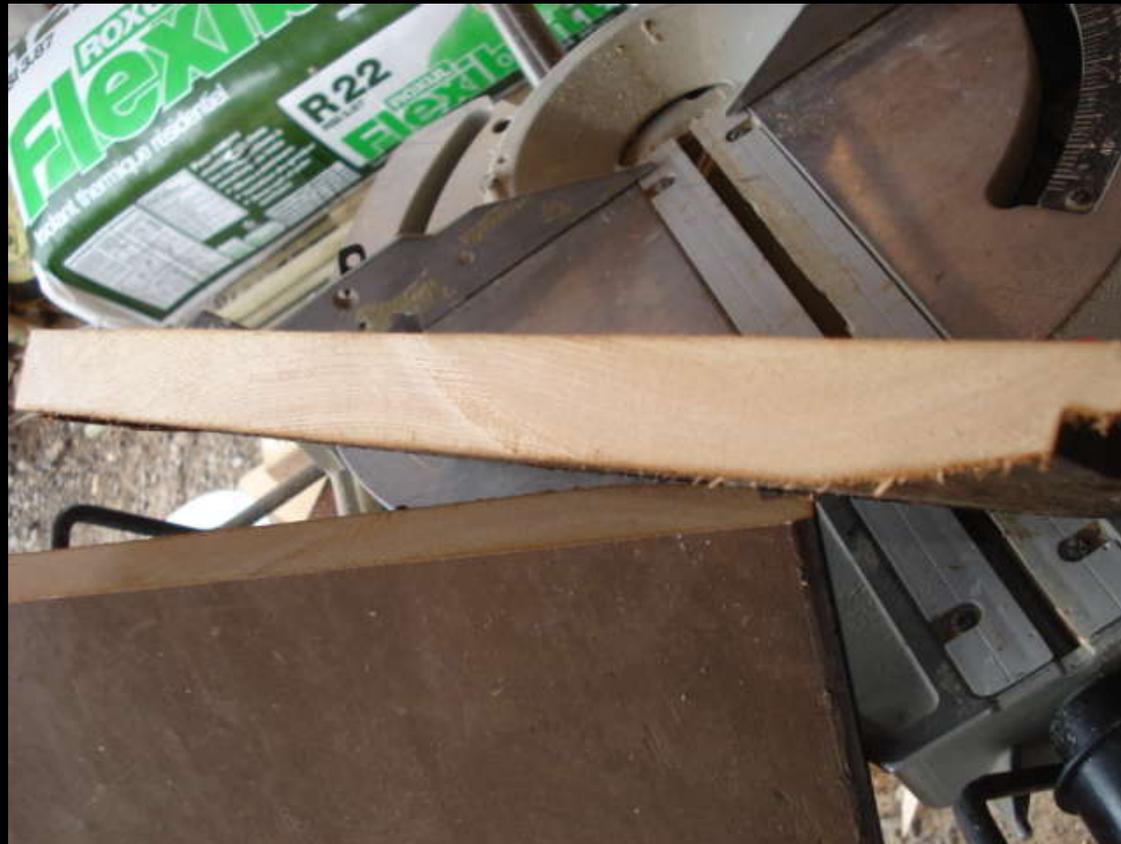
The grain indicates this was sawn from a huge pine tree - 1860

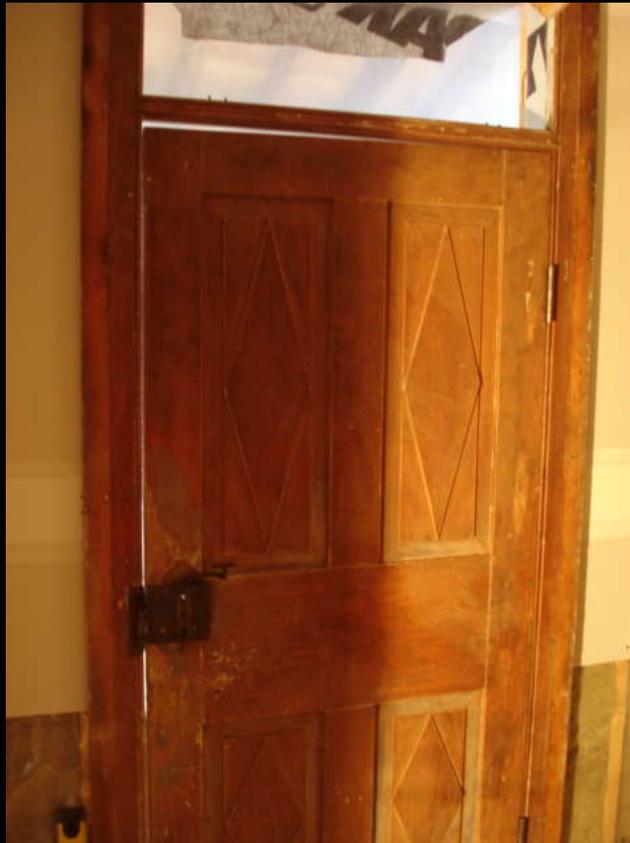
Porch door being installed – note how the door is hung on the trim and not on the jamb

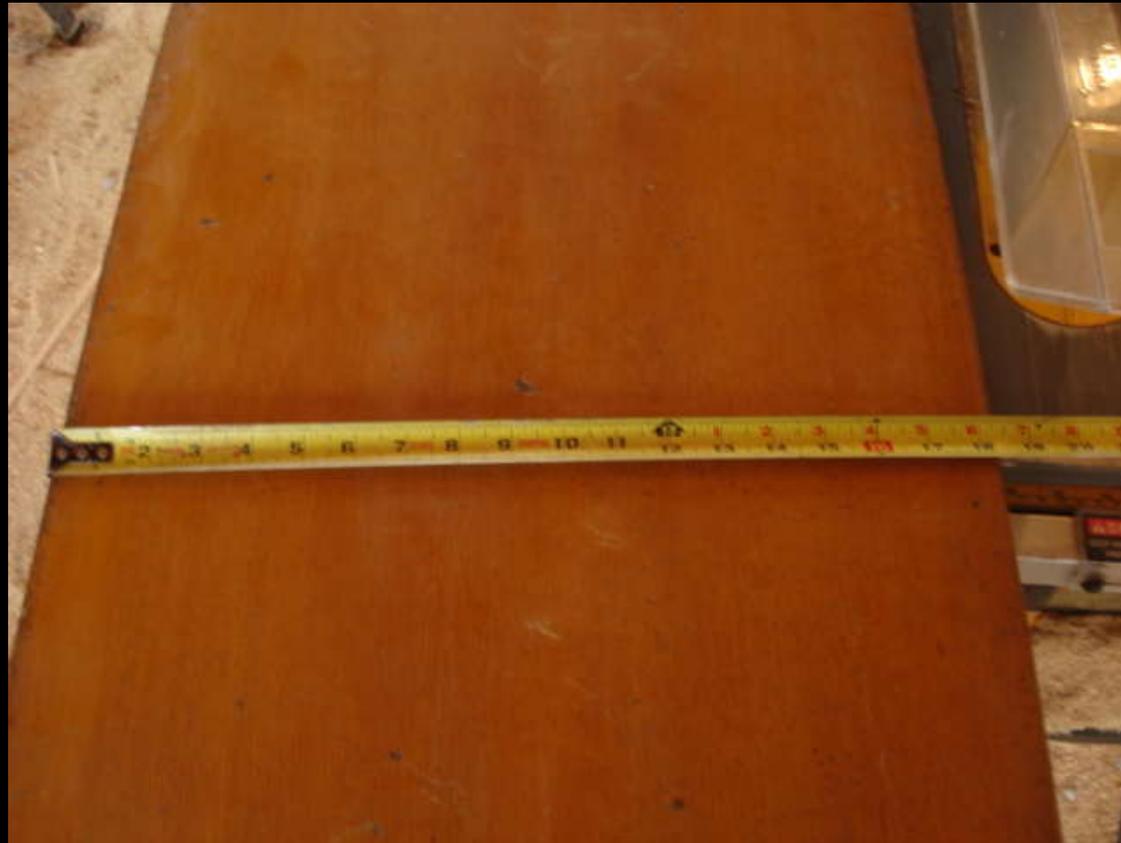
One board, 1860, 18 1/2" wide

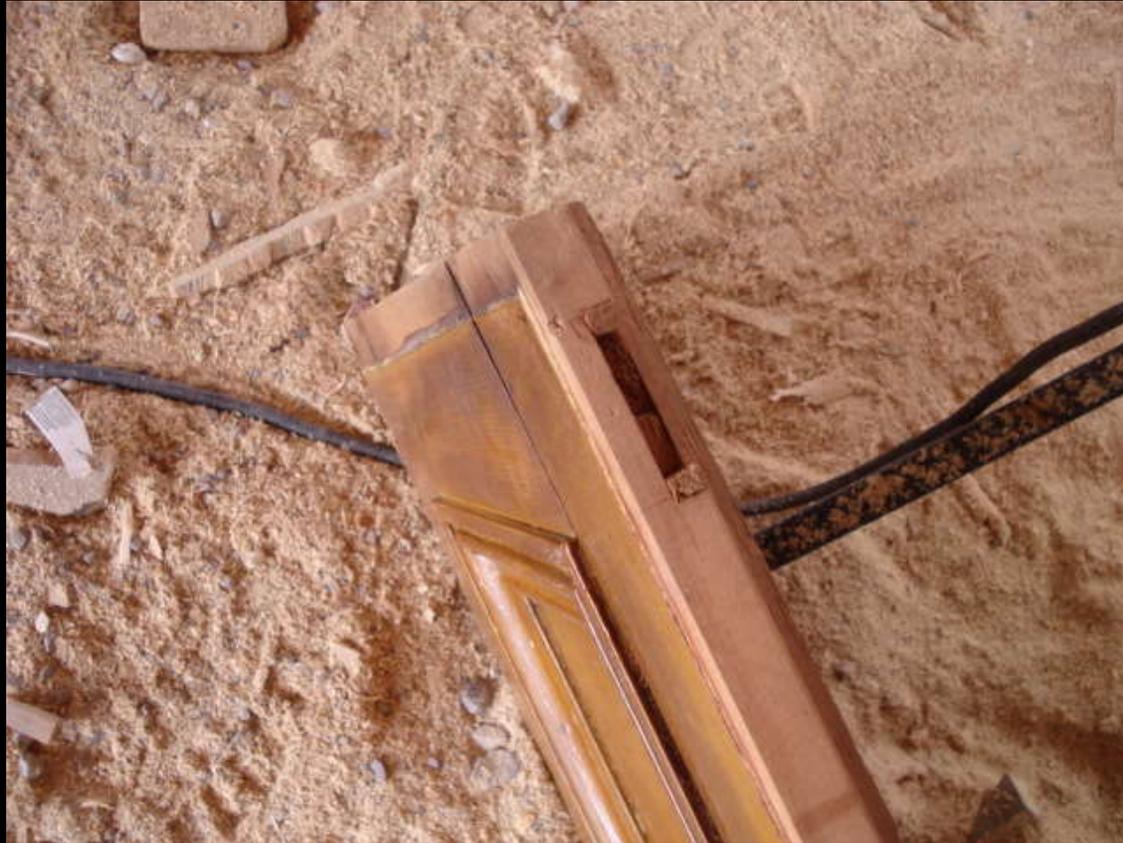
Mortise & tenon - 1860

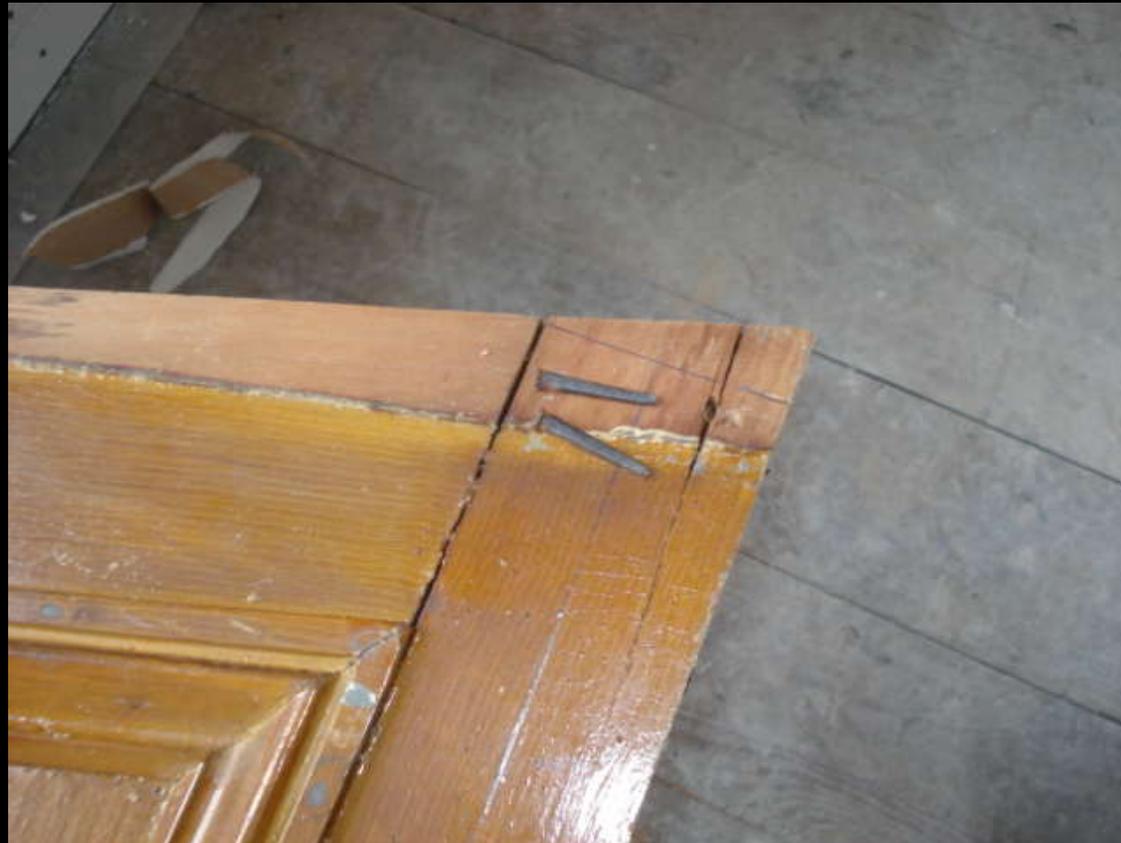
**It had been joined at the corners
with square nails**

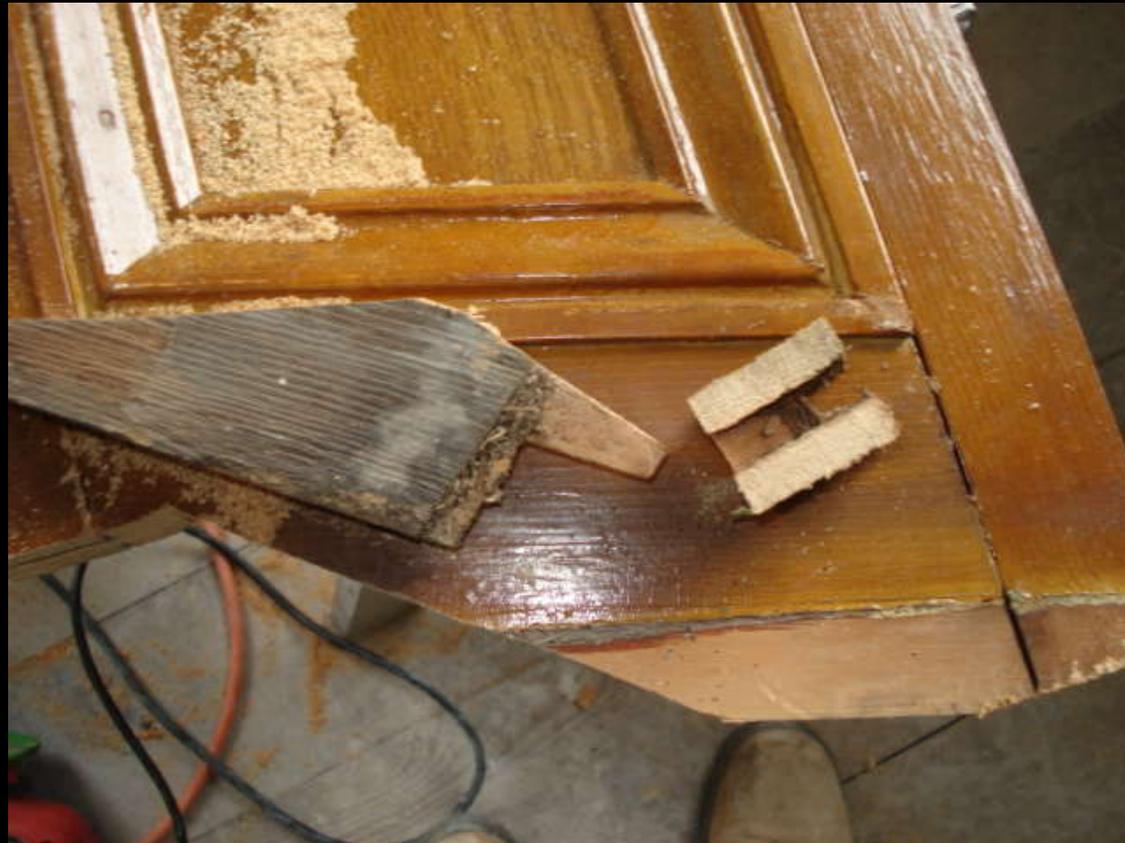
No glue in this joint

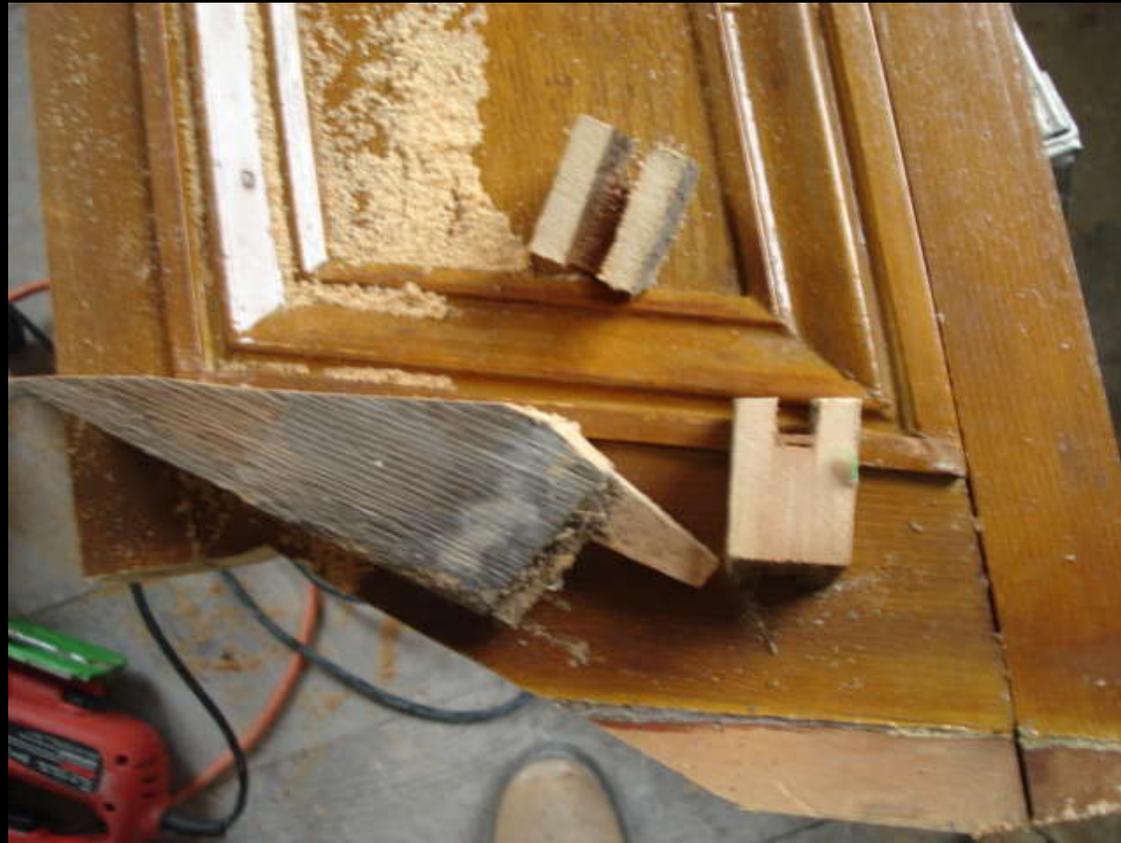
Joints were made by handsaw

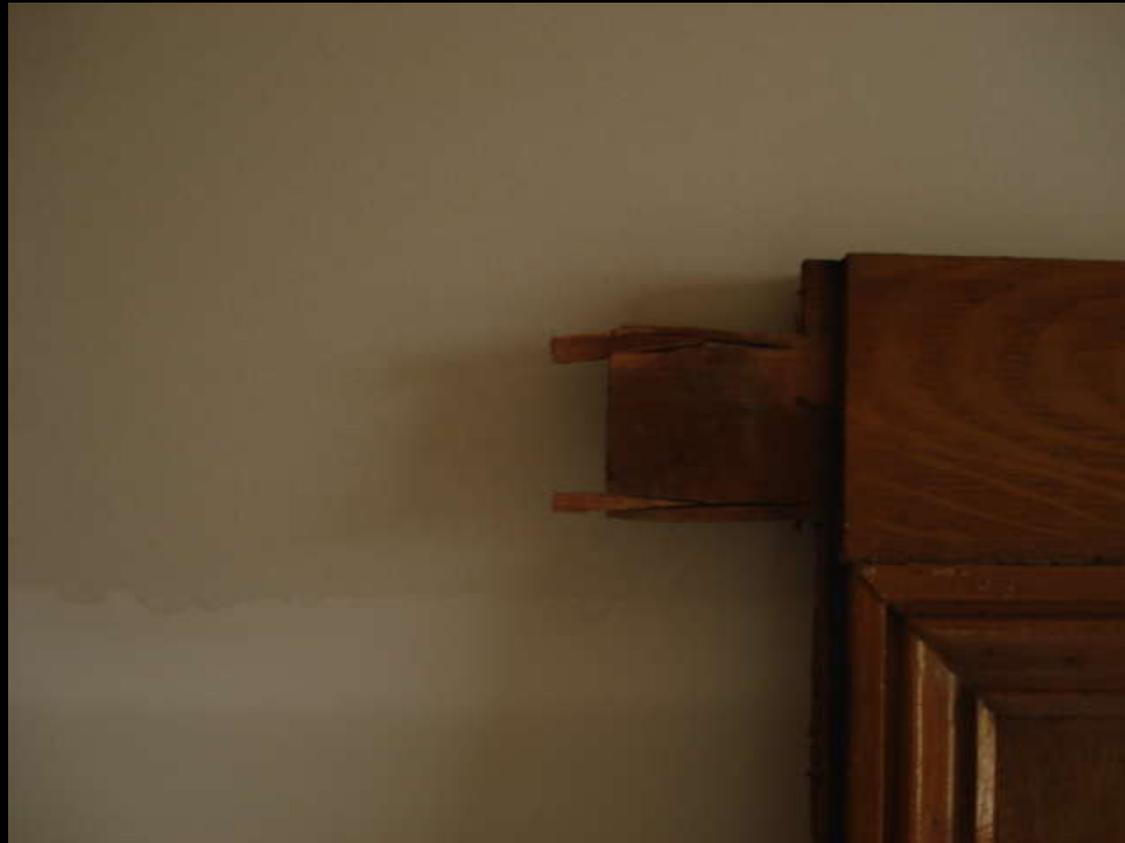
Wedges – no glue

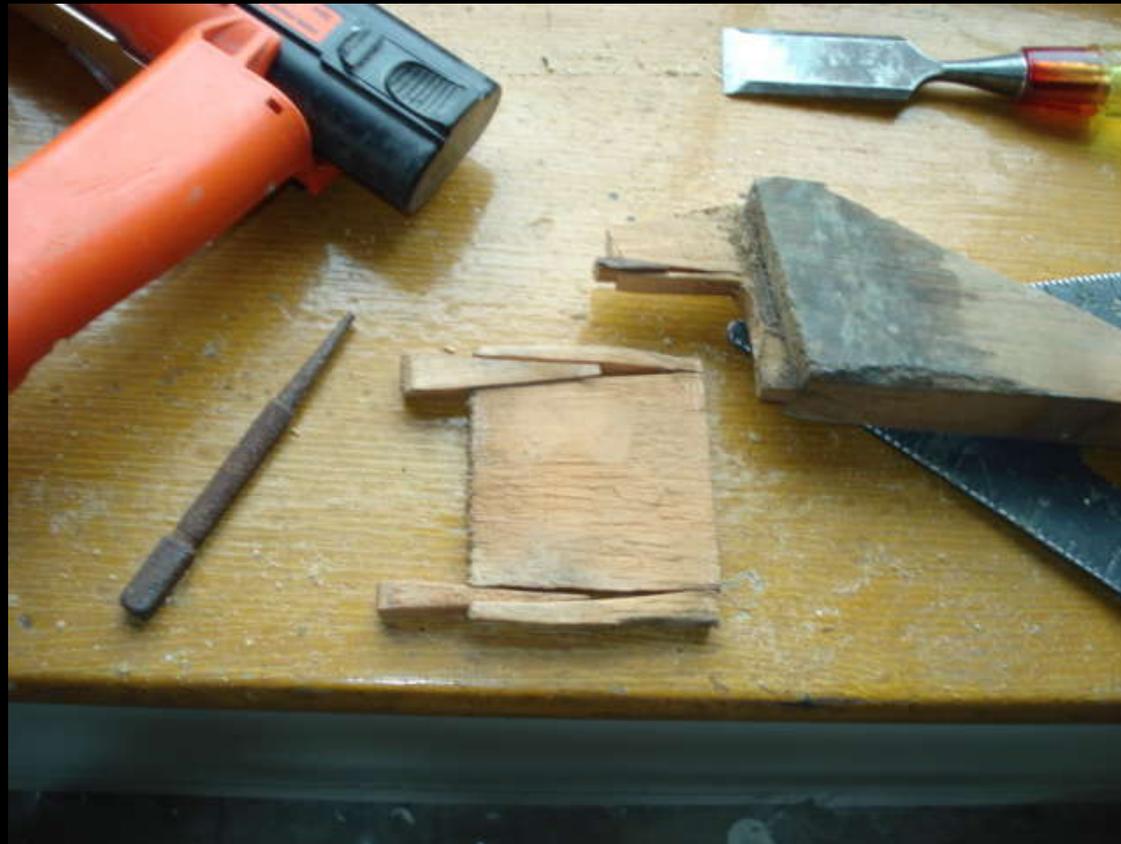
The tongue was split top & bottom and wedges driven in to tighten – and no glue was used – and it held since 1860!
